**Flood Control Project Maintenance
Levee Inspections**

Fall 2008 Levee Maintenance Deficiency Summary Report

Reclamation District No. 0150

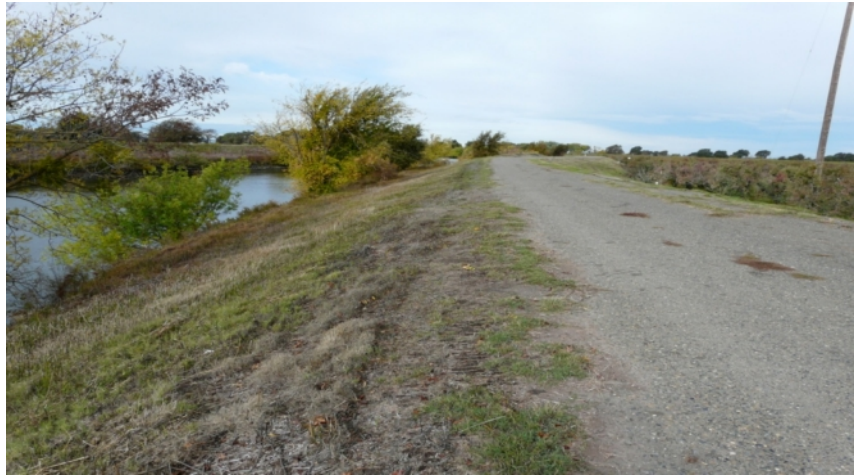
Levee Mile Report Line	1
Start Levee Mile	0.00
End Levee Mile	0.01
Location	
Category	Earthen Levee
Item	Vegetation
Example of good vegetation control on waterward slope on this unit.

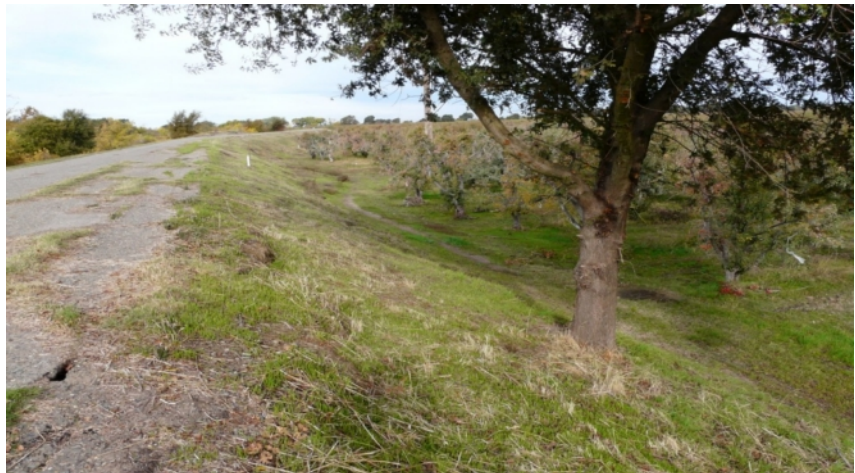
Levee Mile Report Line	2
Start Levee Mile	0.00
End Levee Mile	0.01
Location	
Category	Earthen Levee
Item	Vegetation
Example of good vegetation control on landward slope on this unit.

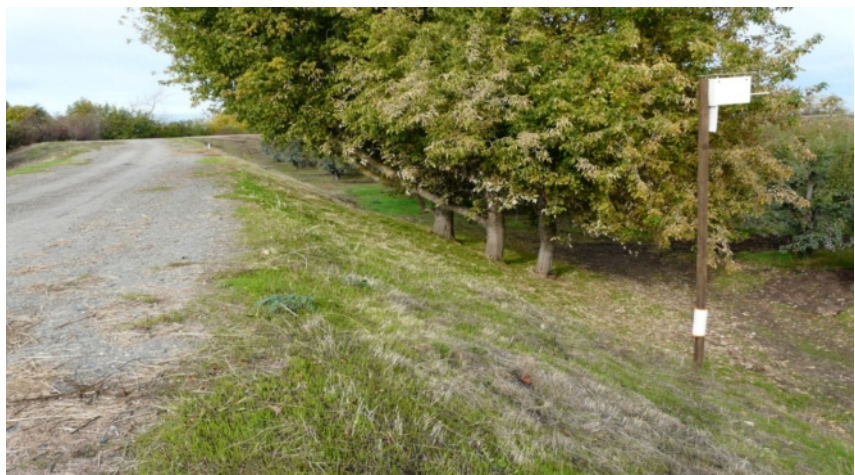
Levee Mile Report Line	2
Start Levee Mile	0.00
End Levee Mile	0.01
Location	
Category	Earthen Levee
Item	Vegetation
Example of good tree trimming on landward slope on this unit.

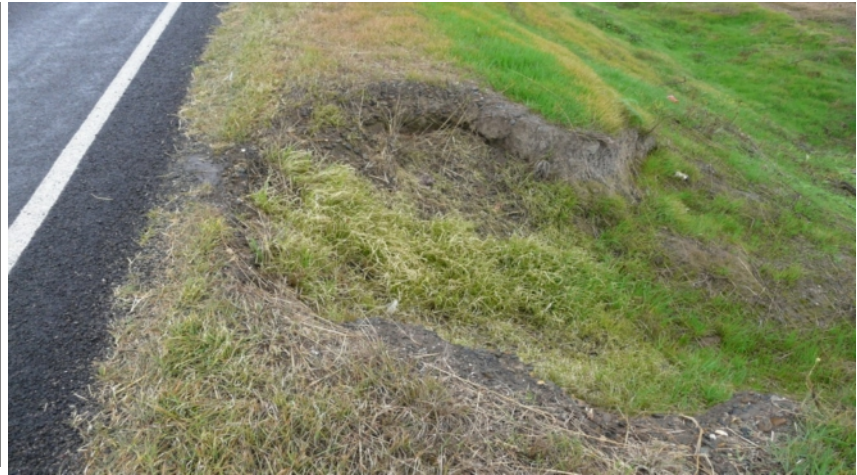
Levee Mile Report Line	1
Start Levee Mile	0.06
End Levee Mile	0.06
Location	
Category	Earthen Levee
Item	Erosion / Bank Caving
Repair erosion/slumping on landside slope of levee at LM 0.06

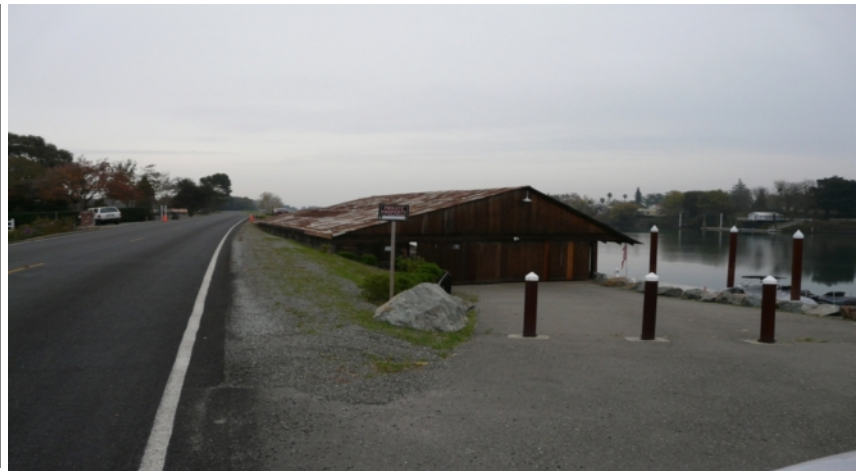
Levee Mile Report Line	2
Start Levee Mile	0.16
End Levee Mile	0.16
Location	
Category	Earthen Levee
Item	Encroachments
Building located on waterside of levee at LM 0.16

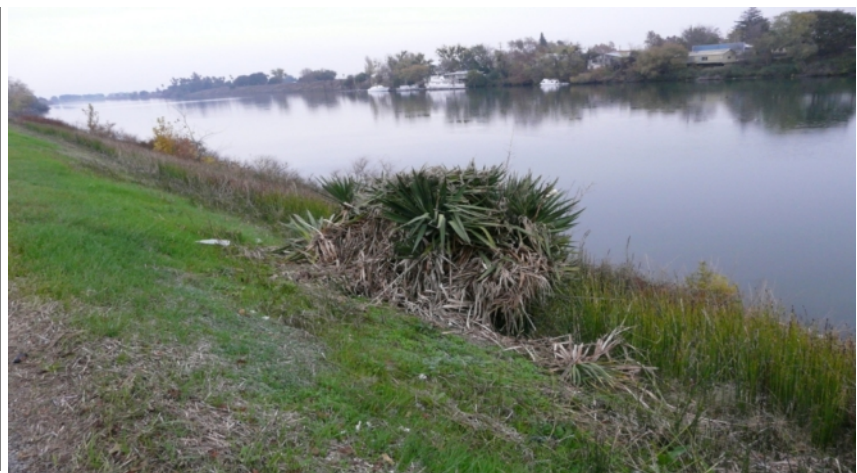
Levee Mile Report Line	3
Start Levee Mile	0.24
End Levee Mile	0.24
Location	
Category	Earthen Levee
Item	Vegetation
Remove century plant within 20' of waterside shoulder on waterside of the levee at LM 0.24

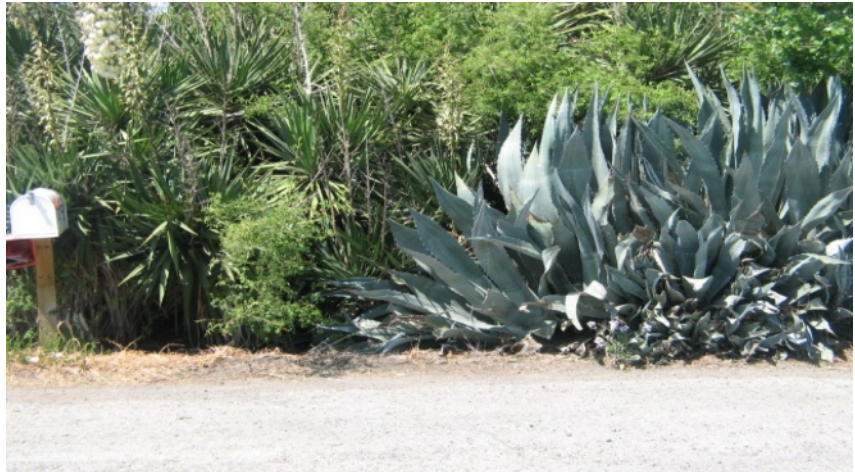
Levee Mile Report Line	4
Start Levee Mile	0.25
End Levee Mile	0.25
Location	
Category	Earthen Levee
Item	Encroachments
Landscaping on landward slope at LM 0.25 blocking view of levee slope.

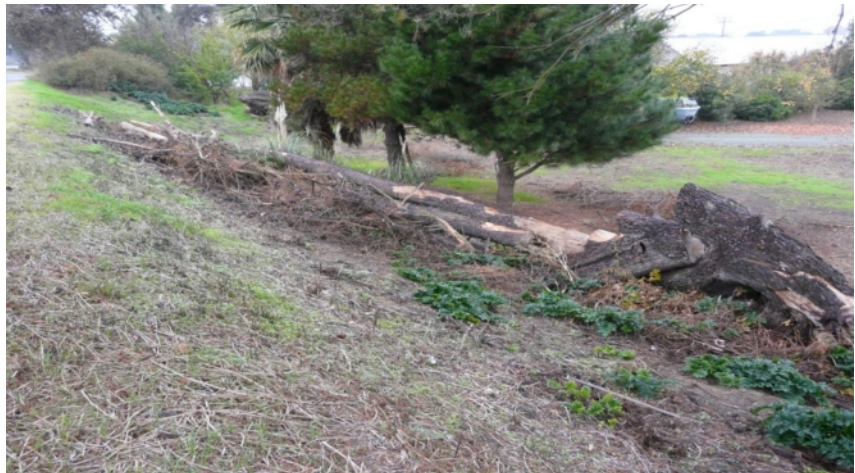
Levee Mile Report Line	5
Start Levee Mile	0.27
End Levee Mile	0.27
Location	
Category	Earthen Levee
Item	Encroachments
Remove tree branches from landside of levee at LM 0.27

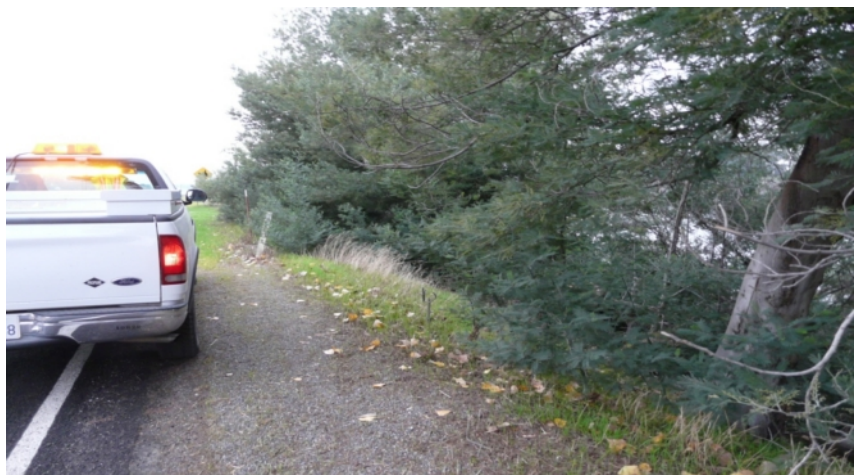
Levee Mile Report Line	6
Start Levee Mile	0.59
End Levee Mile	0.59
Location	
Category	Earthen Levee
Item	Trim / Thin Trees
Trim trees above 5' from surface of the wateside of the levee within 20' from shoulder at LM 0.59

6	0.59	0.59	Earthen Levee	Trim / Thin Trees	WS	M	Trim and thin trees to allow visibility of the ground and room to flood fight.	38.334776 ° -121.569760 °	38.334776 ° -121.569760 °	Y	51
7	0.59	0.59	Earthen Levee	Trim / Thin Trees	WS	M	Trim trees to at least five feet above ground level.	38.334795 ° -121.569642 °	38.334795 ° -121.569642 °		5
8	0.82	0.82	Earthen Levee	Vegetation	LS	A	Remove the wild growth other than native grasses from the levee slopes.	38.337455 ° -121.567289 °	38.337455 ° -121.567289 °	Y	93
9	0.98	1.00	Earthen Levee	Trim / Thin Trees	LS	M	Trim trees to at least five feet above ground level.	38.339042 ° -121.565209 °	38.339307 ° -121.564860 °		6
10	1.09	1.12	Earthen Levee	Trim / Thin Trees	LS	M	Trim trees to at least five feet above ground level.	38.340042 ° -121.563693 °	38.340397 ° -121.563375 °		7
11	1.25	1.28	Boat Survey	Boat Survey Erosion	LS	M	Inspector Comments: none	38.342078 ° -121.561436 °	38.341617 ° -121.561686 °		946

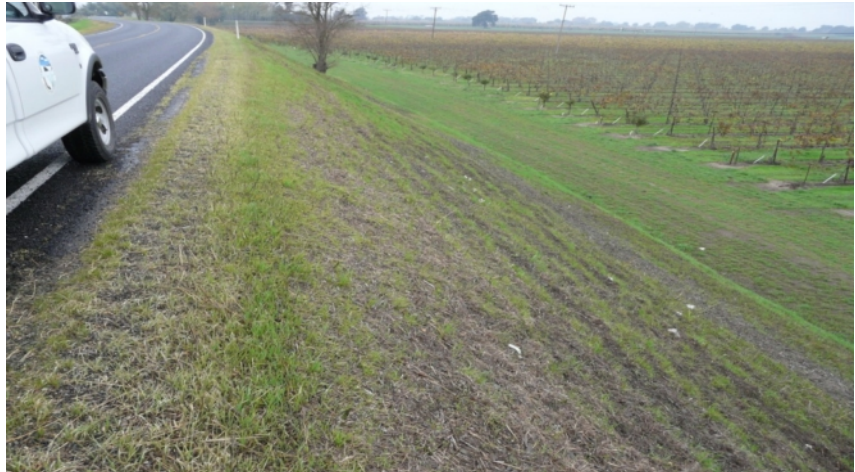
Levee Mile Report Line	8
Start Levee Mile	0.82
End Levee Mile	0.82
Location	
Category	Earthen Levee
Item	Vegetation
Example of good vegetation control on landside of levee at LM 0.82

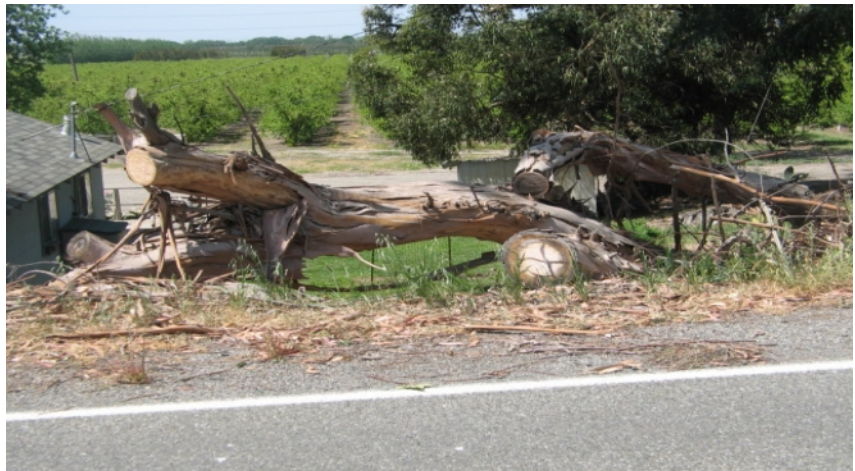
Levee Mile Report Line	23
Start Levee Mile	2.84
End Levee Mile	2.84
Location	
Category	Earthen Levee
Item	Encroachments
Down tree limbs on landward slope at LM 2.84

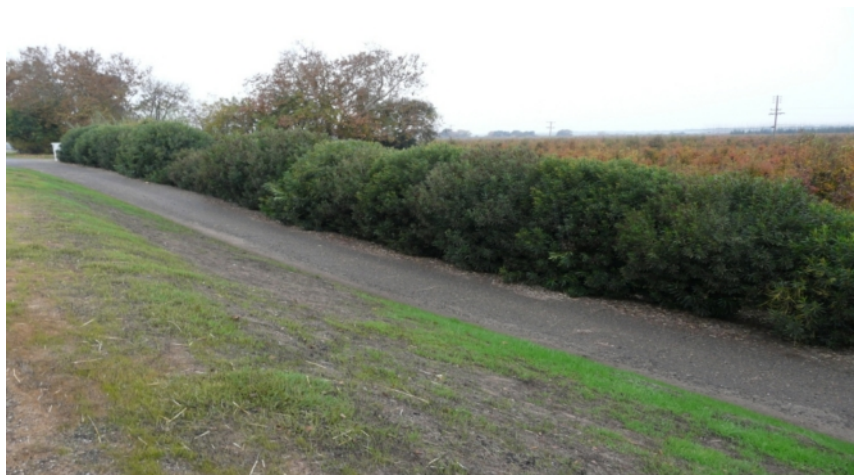
Levee Mile Report Line	24
Start Levee Mile	3.02
End Levee Mile	3.06
Location	
Category	Earthen Levee
Item	Encroachments
Landscaping providing a screen for a residence on landside of levee from LM 3.02 to LM 3.06

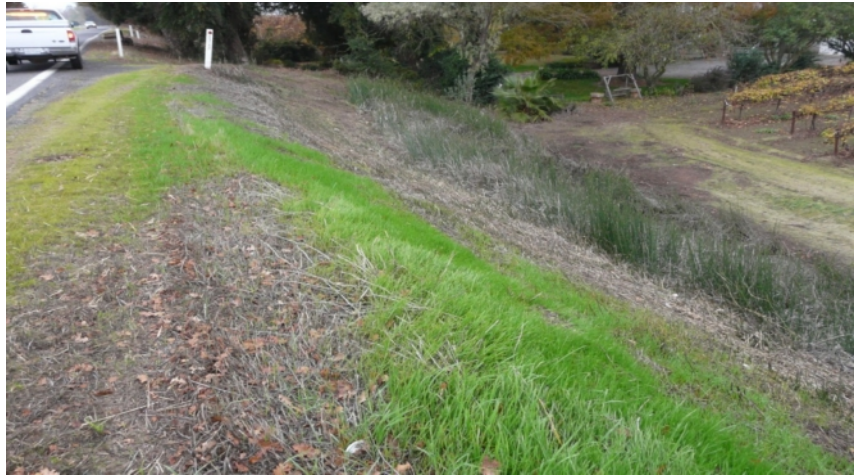
Levee Mile Report Line	27
Start Levee Mile	3.53
End Levee Mile	3.56
Location	
Category	Earthen Levee
Item	Vegetation
Remove/mow vegetation along landside of levee from LM 3.53 to LM 3.56

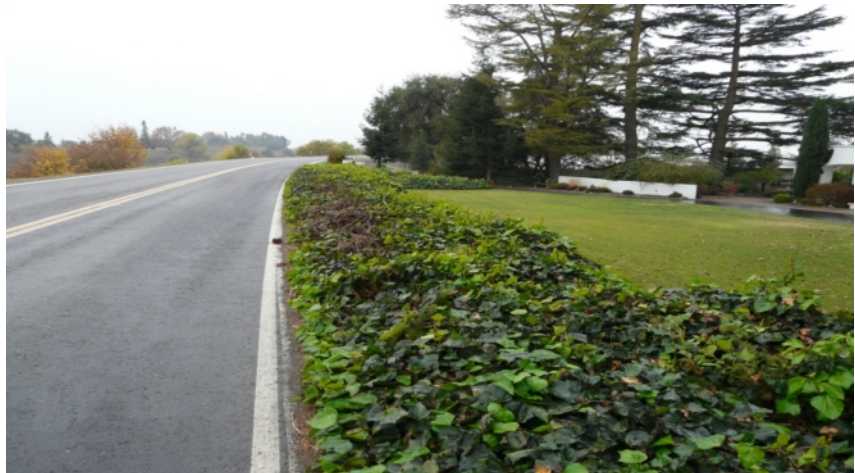
Levee Mile Report Line	30
Start Levee Mile	3.90
End Levee Mile	3.93
Location	
Category	Earthen Levee
Item	Encroachments
Landscaping in front of a residence on landside of levee from LM 3.90 to LM 3.93. The levee in this location is greater than 100' wide.

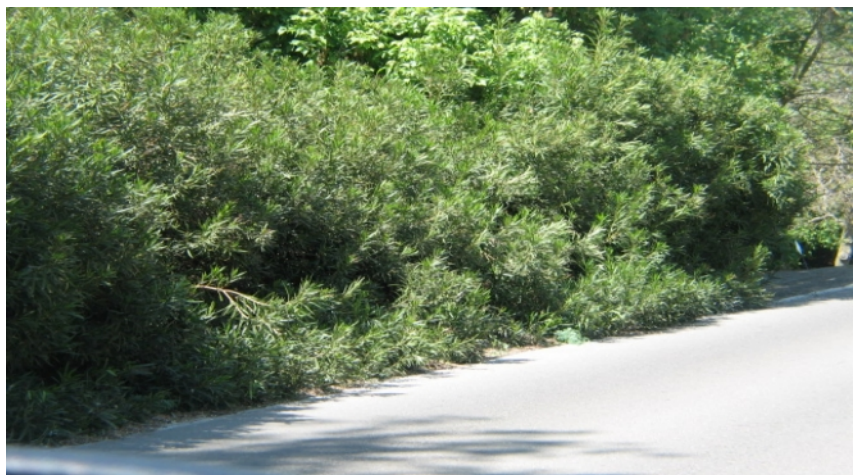
Levee Mile Report Line	31
Start Levee Mile	4.33
End Levee Mile	4.35
Location	
Category	Earthen Levee
Item	Encroachments
Landscaping (Oleander) on landward slope from 4.33 to 4.35

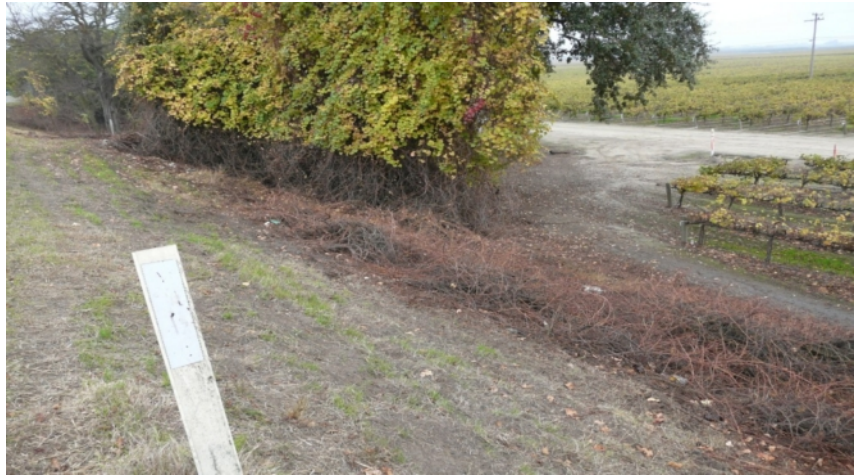
Levee Mile Report Line	33
Start Levee Mile	4.55
End Levee Mile	4.57
Location	
Category	Earthen Levee
Item	Vegetation
Remove/mow vegetation on landside of levee to allow for visibility from LM 4.55 to LM 4.57

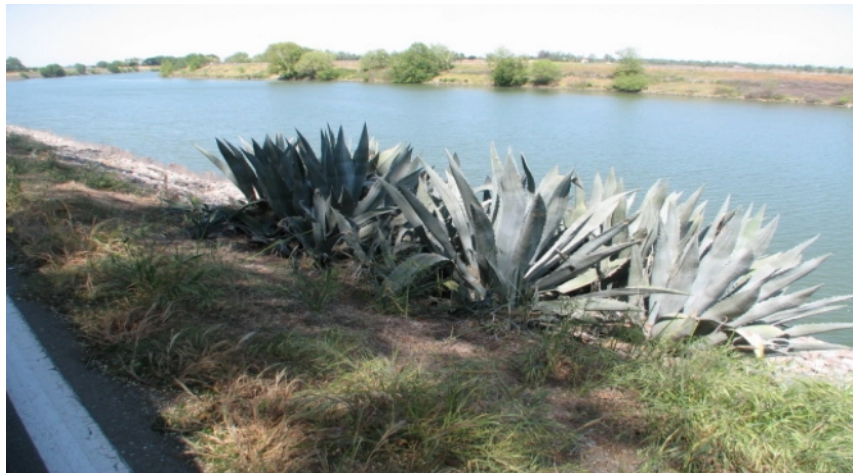
Levee Mile Report Line	35
Start Levee Mile	4.76
End Levee Mile	4.76
Location	
Category	Earthen Levee
Item	Vegetation
Century plant on waterward slope at LM 4.76

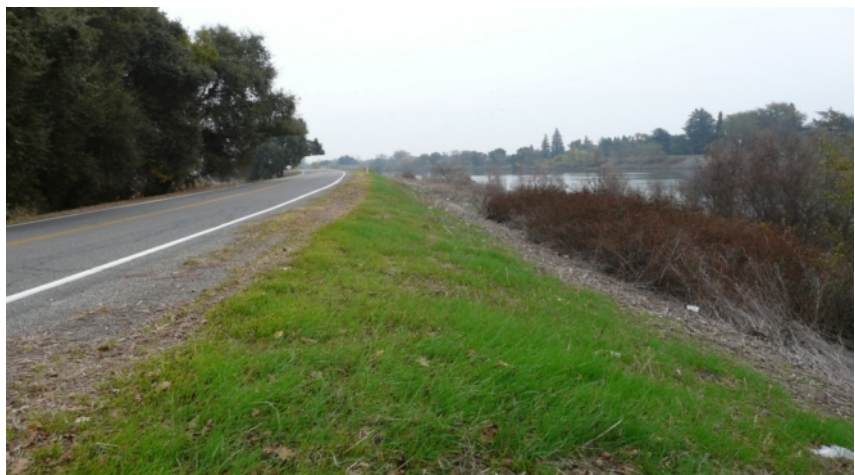
Levee Mile Report Line	42
Start Levee Mile	5.74
End Levee Mile	5.74
Location	
Category	Earthen Levee
Item	Vegetation
Example of good vegetation control on waterside of levee at LM 5.74

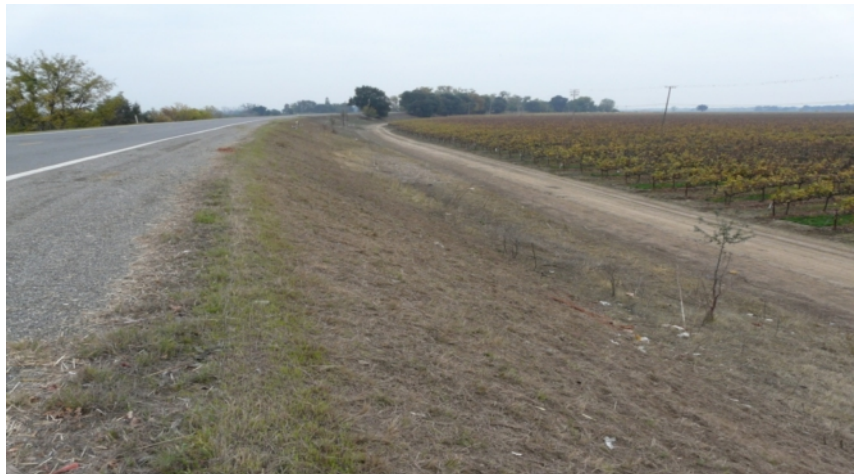
Levee Mile Report Line	43
Start Levee Mile	6.03
End Levee Mile	6.03
Location	
Category	Earthen Levee
Item	Vegetation
Example of good vegetation control on landside of levee at LM 6.03

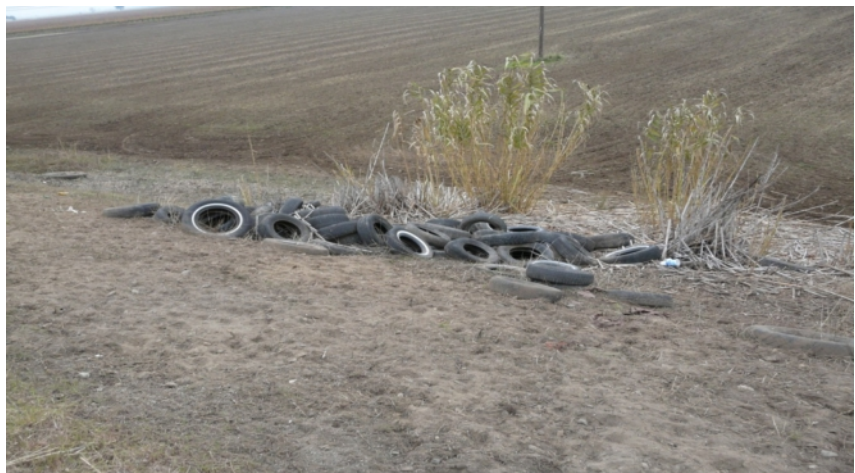
Levee Mile Report Line	45
Start Levee Mile	6.28
End Levee Mile	6.28
Location	
Category	Earthen Levee
Item	Encroachments
Remove tires from landside of levee at LM 6.28

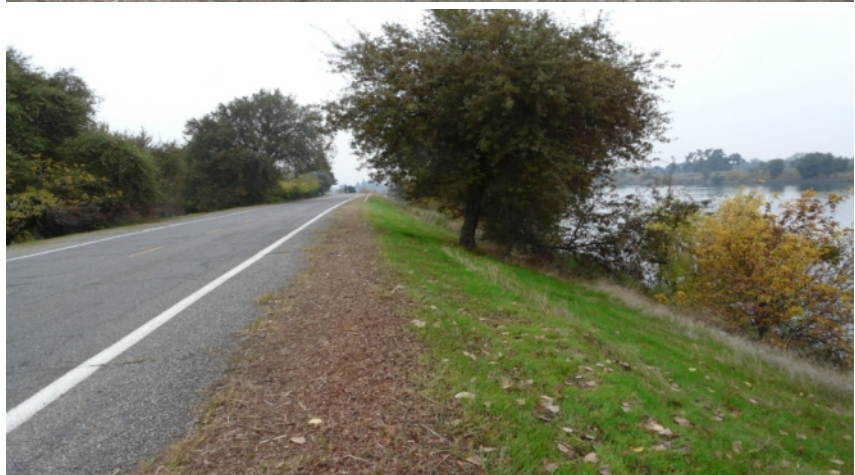
Levee Mile Report Line	46
Start Levee Mile	6.35
End Levee Mile	6.35
Location	
Category	Earthen Levee
Item	Trim / Thin Trees
Example of good tree trimming on waterside of levee at LM 6.35

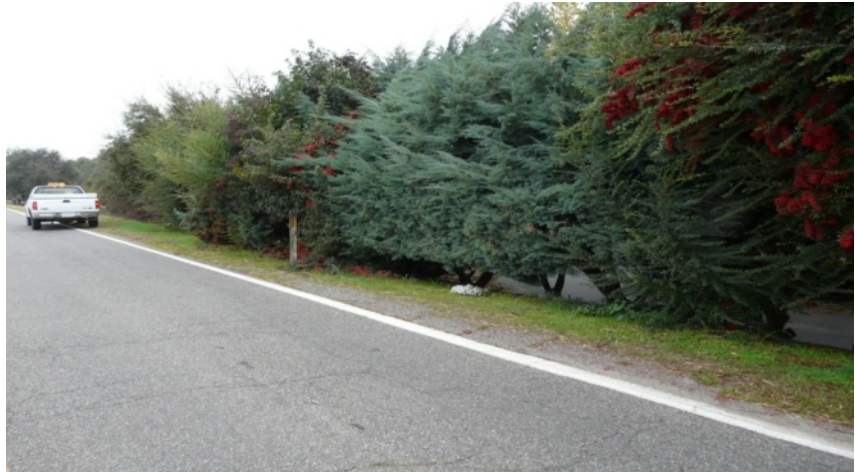
Levee Mile Report Line	53
Start Levee Mile	6.68
End Levee Mile	6.72
Location	
Category	Earthen Levee
Item	Encroachments
Landscaping providing a screen for a residence on landside of levee from LM 6.68 to LM 6.72

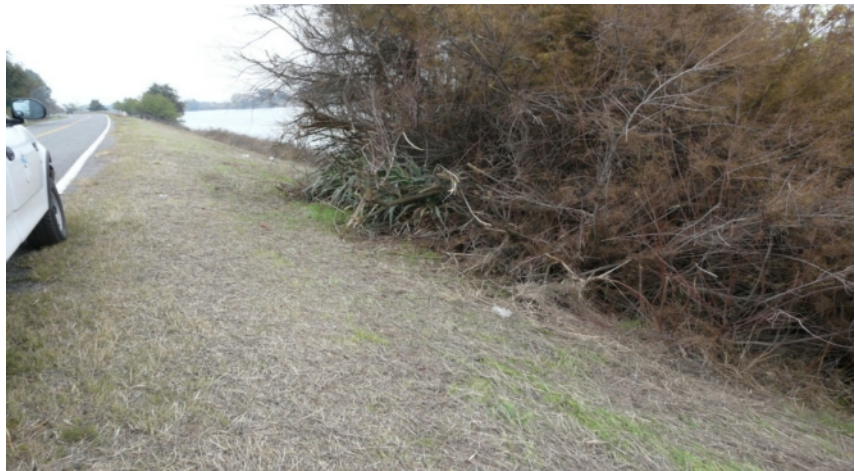
Levee Mile Report Line	54
Start Levee Mile	6.75
End Levee Mile	6.75
Location	
Category	Earthen Levee
Item	Trim / Thin Trees
Trim/thin trees and brush on waterside of levee within 20' of shoulder to allow visibility at LM 6.75

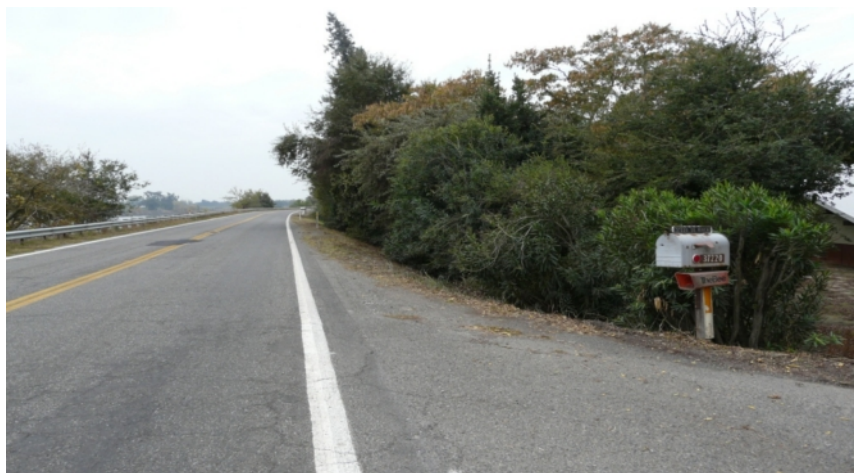
Levee Mile Report Line	58
Start Levee Mile	6.93
End Levee Mile	7.05
Location	
Category	Earthen Levee
Item	Encroachments
Landscaping providing a screen for a residence on landside of levee from LM 6.93 to LM 7.05

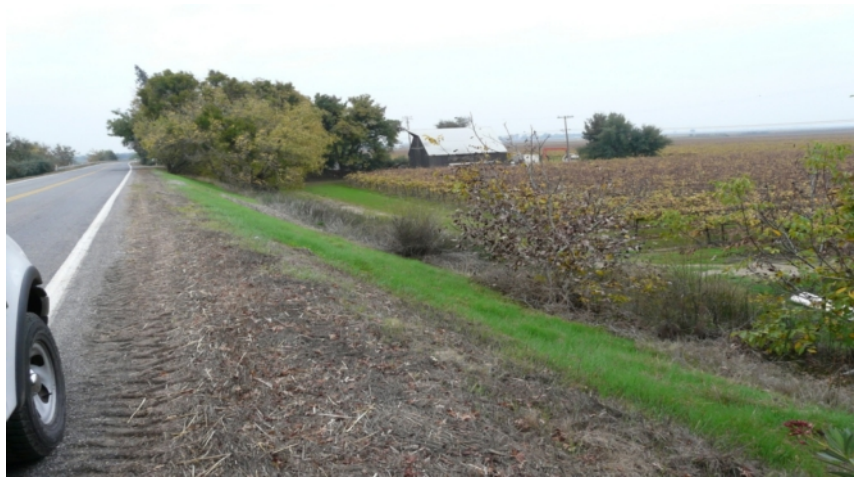
Levee Mile Report Line	59
Start Levee Mile	7.07
End Levee Mile	7.12
Location	
Category	Earthen Levee
Item	Vegetation
Remove/mow vegetation along bottom of landside slope of levee from LM 7.07 to LM 7.12

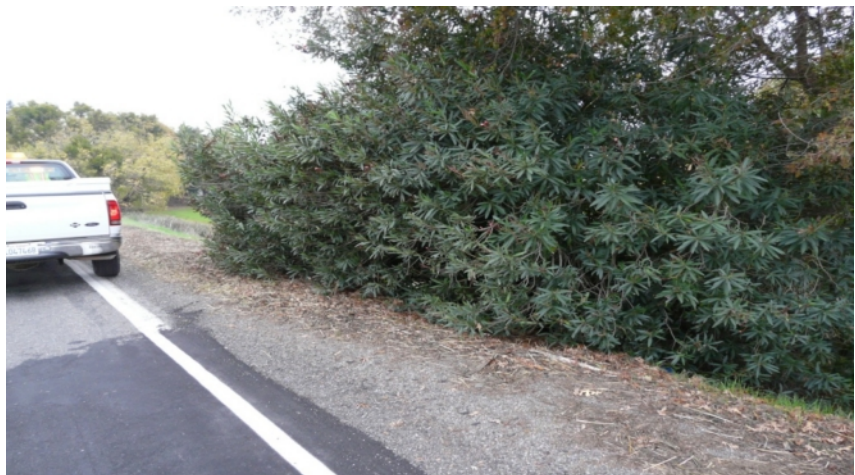
Levee Mile Report Line	60
Start Levee Mile	7.12
End Levee Mile	7.12
Location	
Category	Earthen Levee
Item	Encroachments
Landscaping providing a screen for a residence on landside of levee at LM 7.12

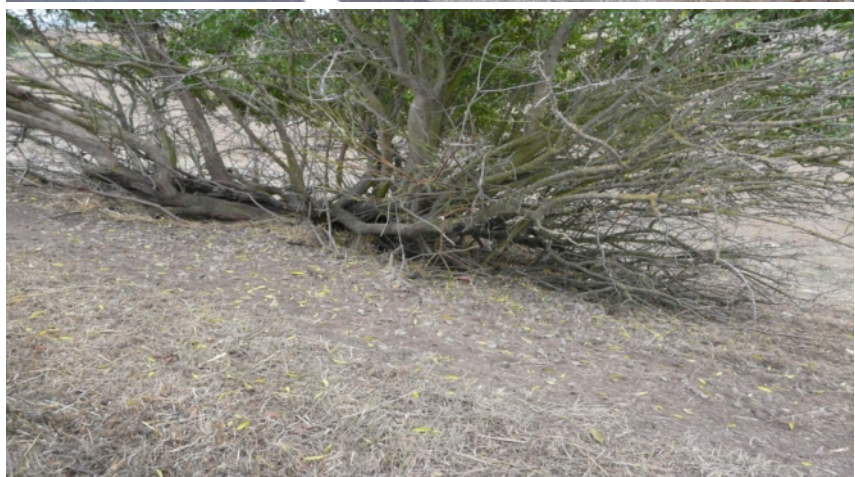
Levee Mile Report Line	62
Start Levee Mile	7.25
End Levee Mile	7.25
Location	
Category	Earthen Levee
Item	Trim / Thin Trees
Trim or remove brush to allow for visibility on landside of levee at LM 7.25

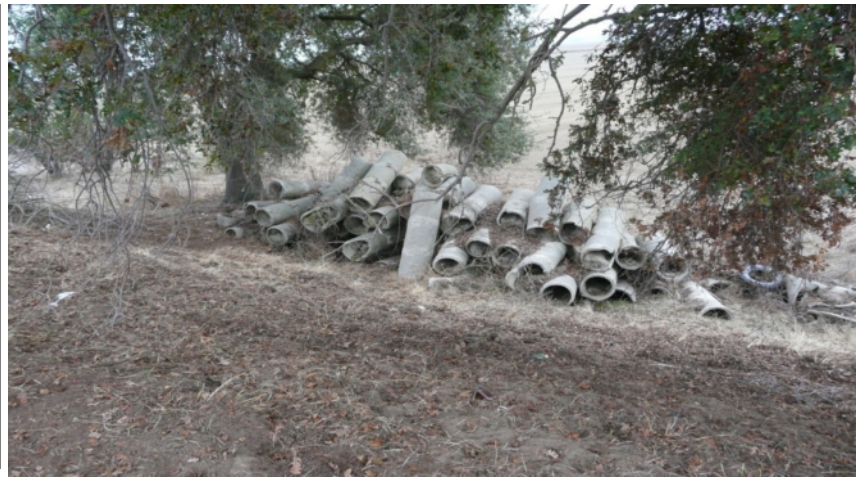
Levee Mile Report Line	63
Start Levee Mile	7.32
End Levee Mile	7.32
Location	
Category	Earthen Levee
Item	Encroachments
Remove pipes piled on landside of levee to at least 10' from levee toe at LM 7.32

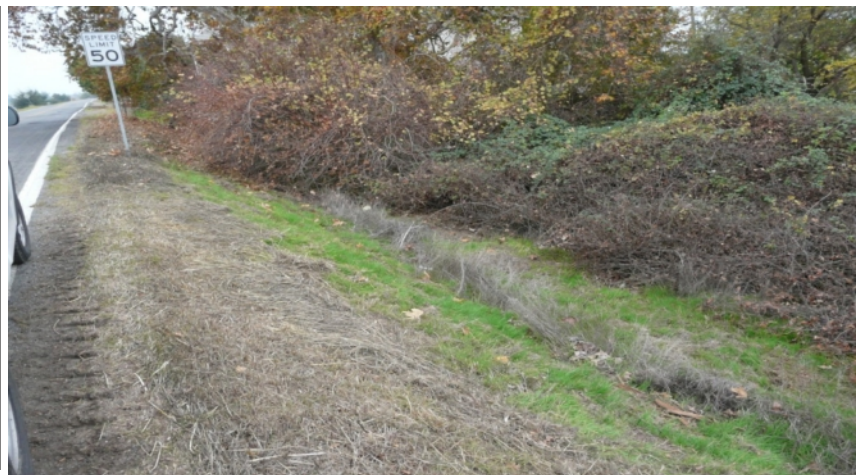
Levee Mile Report Line	64
Start Levee Mile	7.36
End Levee Mile	7.41
Location	
Category	Earthen Levee
Item	Trim / Thin Trees
Trim/thin trees and brush on landside of levee from LM 7.36 to LM 7.41

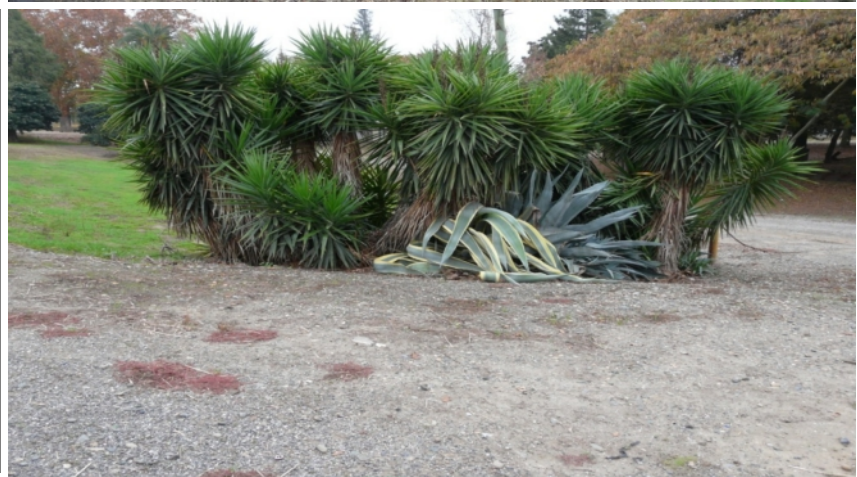
Levee Mile Report Line	65
Start Levee Mile	7.92
End Levee Mile	7.92
Location	
Category	Earthen Levee
Item	Encroachments
Landscaping on landside of levee at LM 7.92

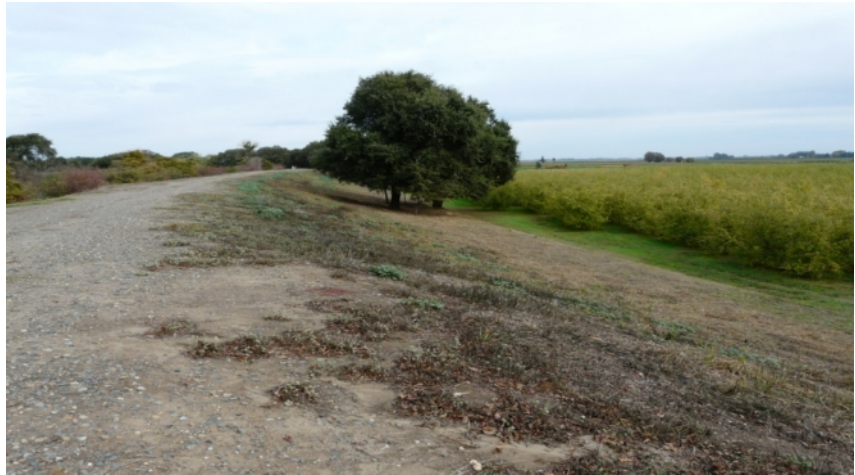
Levee Mile Report Line	1
Start Levee Mile	0.16
End Levee Mile	0.37
Location	
Category	Earthen Levee
Item	Vegetation
Example of good vegetation control on landward slope at LM 0.16 to LM 0.37.

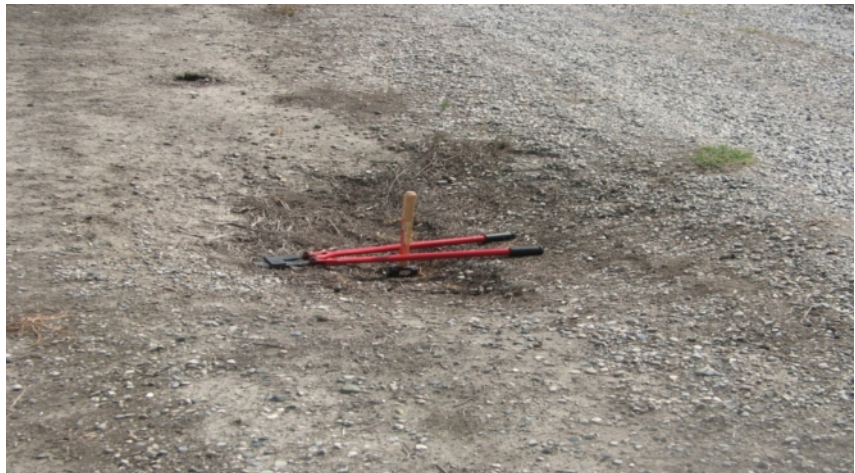
Levee Mile Report Line	4
Start Levee Mile	1.22
End Levee Mile	1.22
Location	
Category	Earthen Levee
Item	Crown Surface / Depressions / Rutting
Minor depression on levee crown at LM 1.22

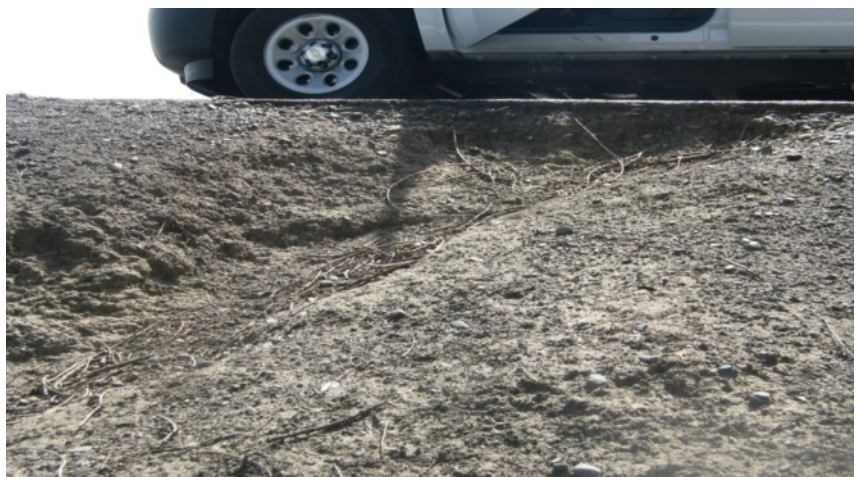
Levee Mile Report Line	5
Start Levee Mile	1.23
End Levee Mile	1.23
Location	
Category	Earthen Levee
Item	Slope Stability
Damage slope from foot traffic and rain runoff at LM 1.23

5	1.23	1.23	Earthen Levee	Slope Stability	LS	M	Repair the levee slope damaged by vehicle traffic and prevent access where possible.	38.347607 ° -121.576130 °	38.347607 ° -121.576130 °	Y	10
6	1.66	1.66	Earthen Levee	Animal Control	LS	M	No rodents visible, but rodent burrows visible; need to backfill and compact or grout borrows.	38.351019 ° -121.572965 °	38.351019 ° -121.572965 °		43
7	2.03	2.06	Earthen Levee	Animal Control	LS	M	No rodents visible, but rodent burrows visible; need to backfill and compact or grout borrows.	38.354792 ° -121.569990 °	38.354689 ° -121.569417 °	Y	44
8	3.17	3.17	Earthen Levee	Vegetation	WS	A	Remove the wild growth other than native grasses from the levee slopes.	38.363795 ° -121.560362 °	38.363795 ° -121.560362 °	Y	46
9	3.43	3.48	Earthen Levee	Erosion / Bank Caving	WS	M	Note and monitor erosion site.	38.363223 ° -121.555962 °	38.363953 ° -121.555382 °	Y	14
10	3.50	3.54	Earthen Levee	Encroachments	LS	PO	Landscaping	38.364251 ° -121.555321 °	38.364772 ° -121.555343 °	Y	47

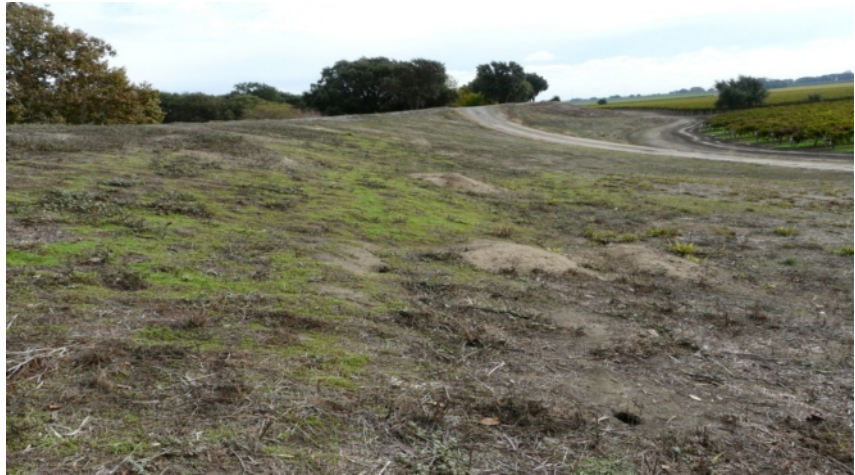
Levee Mile Report Line	7
Start Levee Mile	2.03
End Levee Mile	2.06
Location	
Category	Earthen Levee
Item	Animal Control
Backfill or grout rodent holes at LM 2.03 to LM 2.06.

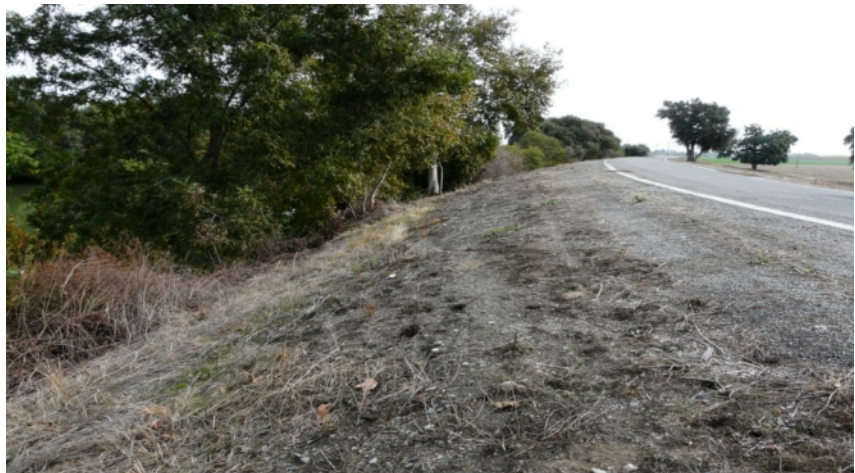
Levee Mile Report Line	8
Start Levee Mile	3.17
End Levee Mile	3.17
Location	
Category	Earthen Levee
Item	Vegetation
Good vegetation control on waterward slope at LM 3.17.

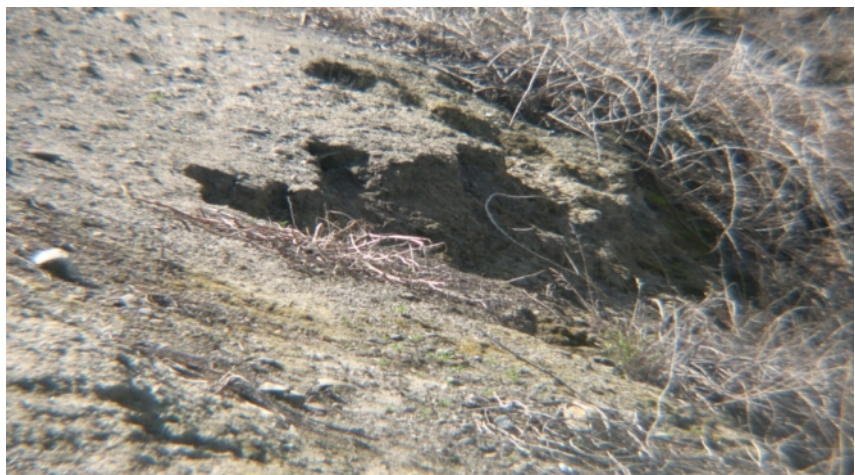
Levee Mile Report Line	9
Start Levee Mile	3.43
End Levee Mile	3.48
Location	
Category	Earthen Levee
Item	Erosion / Bank Caving
Erosion damage on waterward toe from LM 3.43 to 3.48

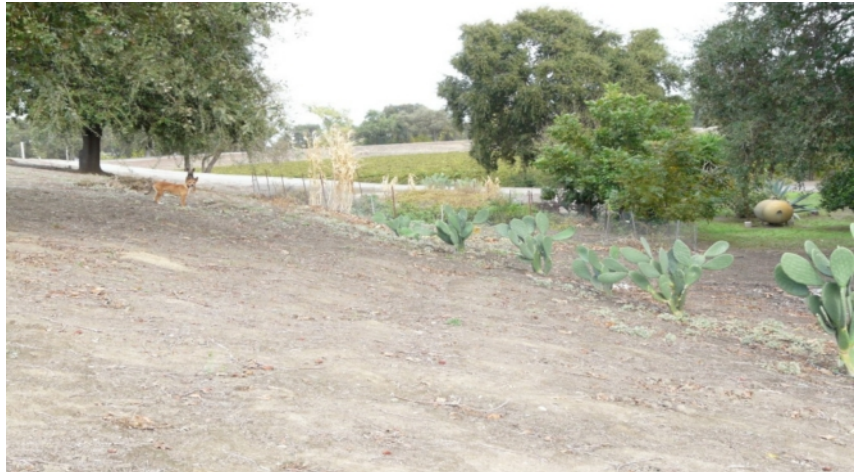
Levee Mile Report Line	10
Start Levee Mile	3.50
End Levee Mile	3.54
Location	
Category	Earthen Levee
Item	Encroachments
Landscaping & garden on landward slope of levee at LM 3.50 to LM 3.54.

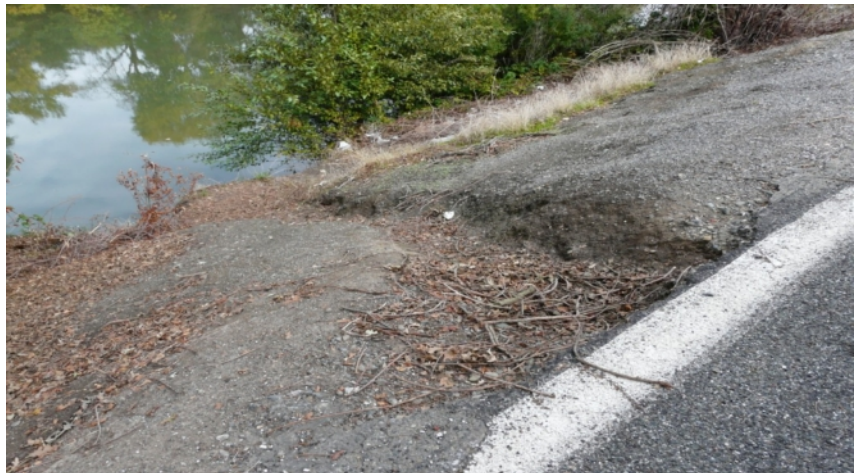
Levee Mile Report Line	11
Start Levee Mile	3.77
End Levee Mile	3.77
Location	
Category	Earthen Levee
Item	Slope Stability
Repair slope damaged by foot traffic at LM 3.77.

11	3.77	3.77	Earthen Levee	Slope Stability	WS	M	Repair the levee slope damaged by foot traffic and prevent access where possible.	38.367393 ° -121.554528 °	38.367393 ° -121.554528 °	Y	15
12	3.95	3.95	Earthen Levee	Encroachments	LS	M	Debris	38.368118 ° -121.551509 °	38.368118 ° -121.551509 °	Y	48
13	4.38	4.38	Earthen Levee	Vegetation	LS	A	Remove the wild growth other than native grasses from the levee slopes.	38.373650 ° -121.550540 °	38.373650 ° -121.550540 °	Y	49
14	4.38	4.38	Earthen Levee	Animal Control	LS	M	No rodents visible, but rodent burrows visible; need to backfill and compact or grout borrows.	38.373649 ° -121.550542 °	38.373649 ° -121.550542 °		50
15	4.46	4.46	Earthen Levee	Encroachments	LS	M	Prunings	38.374269 ° -121.549385 °	38.374269 ° -121.549385 °	Y	51
16	4.51	4.51	Earthen Levee	Encroachments	LS	M	Debris	38.374267 ° -121.548441 °	38.374267 ° -121.548441 °		52
17	4.55	4.58	Earthen Levee	Encroachments	LS	PO	Landscaping	38.374311 ° -121.547802 °	38.374368 ° -121.547263 °	Y	16

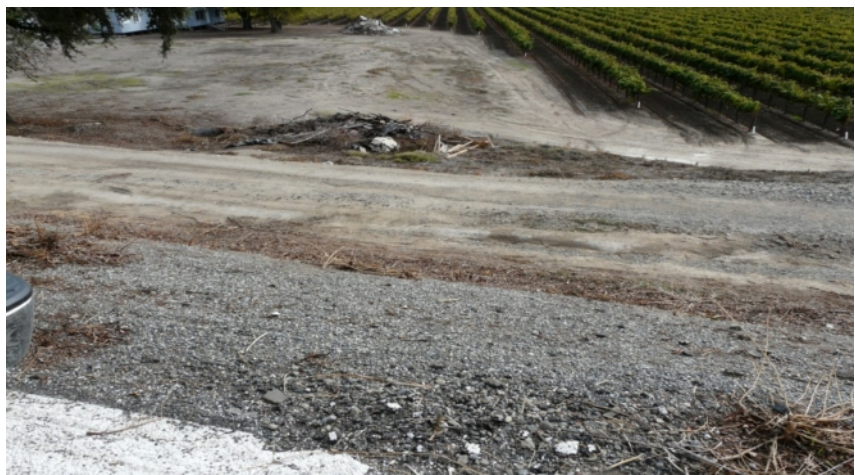
Levee Mile Report Line	12
Start Levee Mile	3.95
End Levee Mile	3.95
Location	
Category	Earthen Levee
Item	Encroachments
Debris pile on landward slope at LM 3.95.

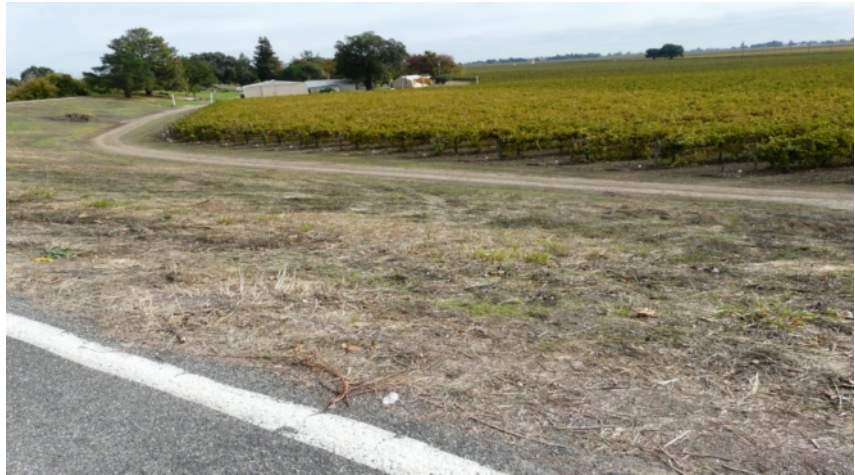
Levee Mile Report Line	13
Start Levee Mile	4.38
End Levee Mile	4.38
Location	
Category	Earthen Levee
Item	Vegetation
Example of good vegetation control along landward slope at LM 4.38.

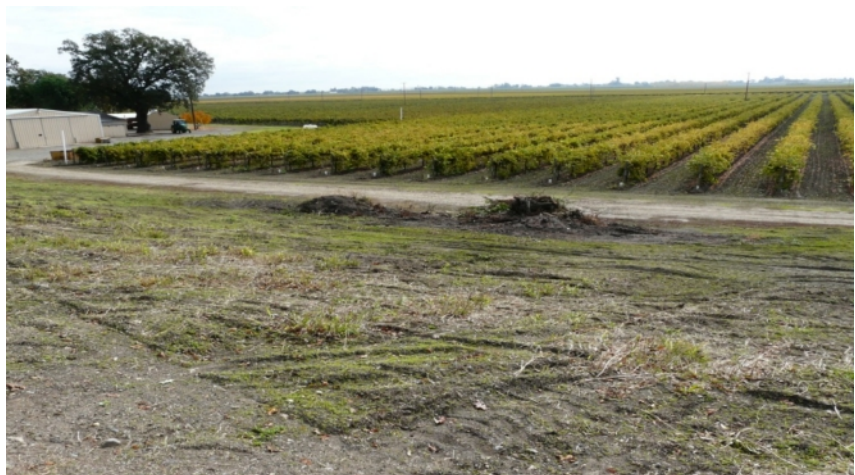
Levee Mile Report Line	15
Start Levee Mile	4.46
End Levee Mile	4.46
Location	
Category	Earthen Levee
Item	Encroachments
Remove pruning pile on landward slope at LM 4.46.

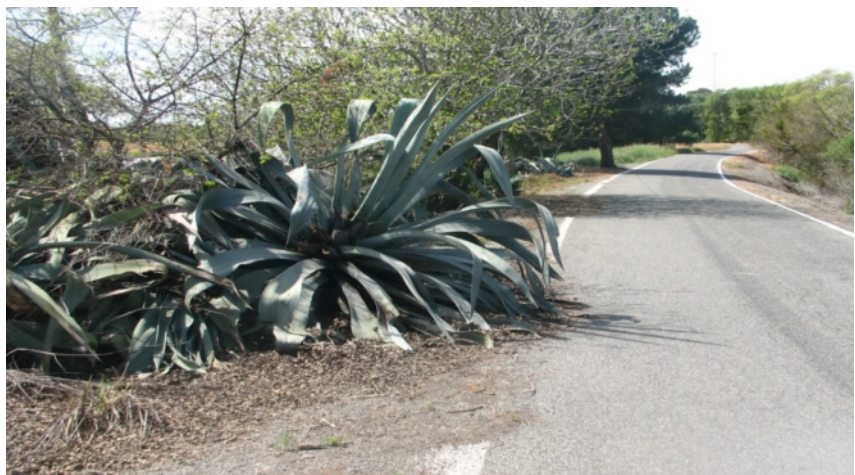
Levee Mile Report Line	17
Start Levee Mile	4.55
End Levee Mile	4.58
Location	
Category	Earthen Levee
Item	Encroachments
Landscaping blocking view of landward slope from 4.50 to 4.58

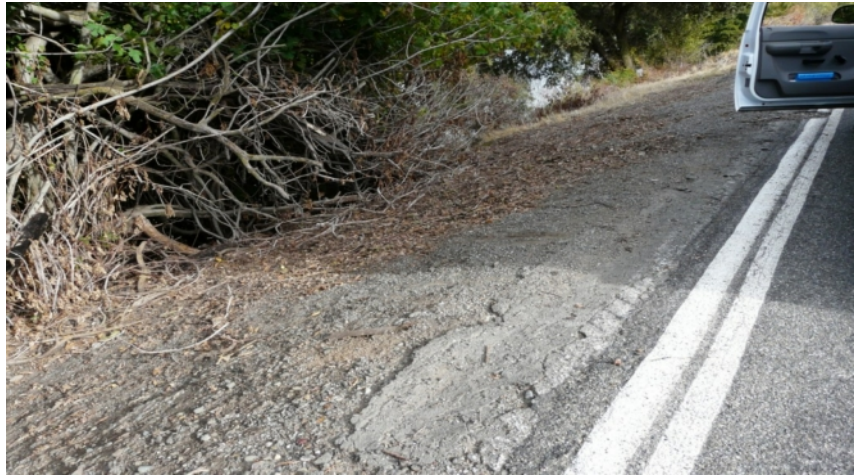
Levee Mile Report Line	18
Start Levee Mile	4.59
End Levee Mile	4.59
Location	
Category	Earthen Levee
Item	Trim / Thin Trees
Thin/trim trees to allow for the top 20' waterward slope of levee to be seen at LM 4.59.

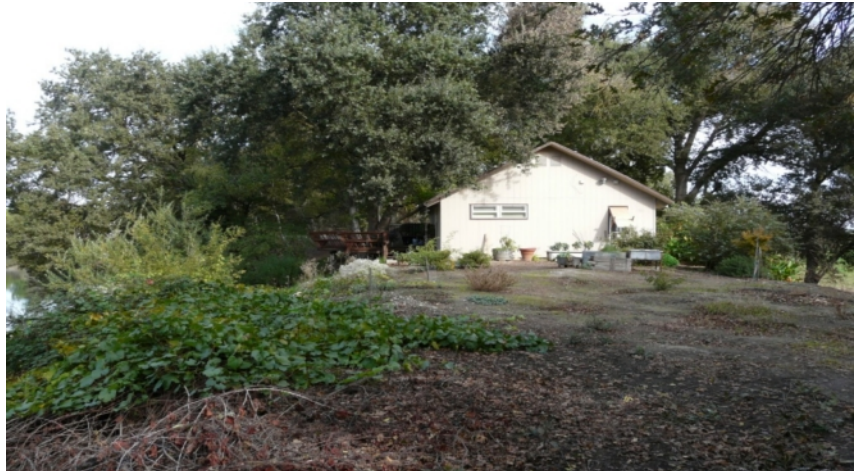
Levee Mile Report Line	23
Start Levee Mile	5.93
End Levee Mile	5.93
Location	
Category	Earthen Levee
Item	Encroachments
Building & associated landscaping on levee crown at LM 5.93.

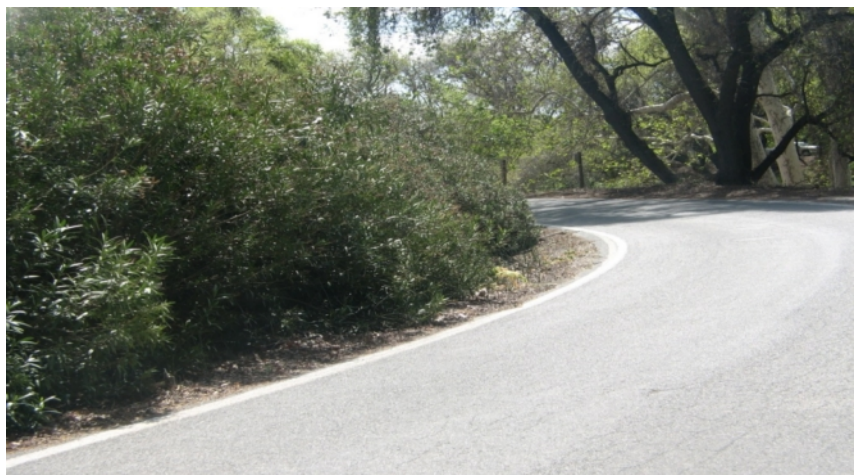
Levee Mile Report Line	26
Start Levee Mile	6.24
End Levee Mile	6.31
Location	
Category	Earthen Levee
Item	Encroachments
Oleander on landward slope blocking view of levee from LM 6.24 to 6.32

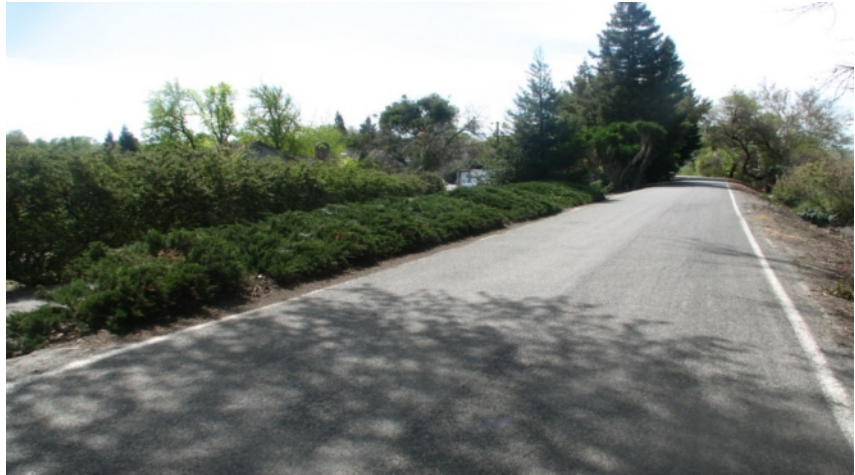
Levee Mile Report Line	28
Start Levee Mile	6.37
End Levee Mile	6.40
Location	
Category	Earthen Levee
Item	Encroachments
Landscaping on landward slope blocking view from LM 6.37 to 6.40

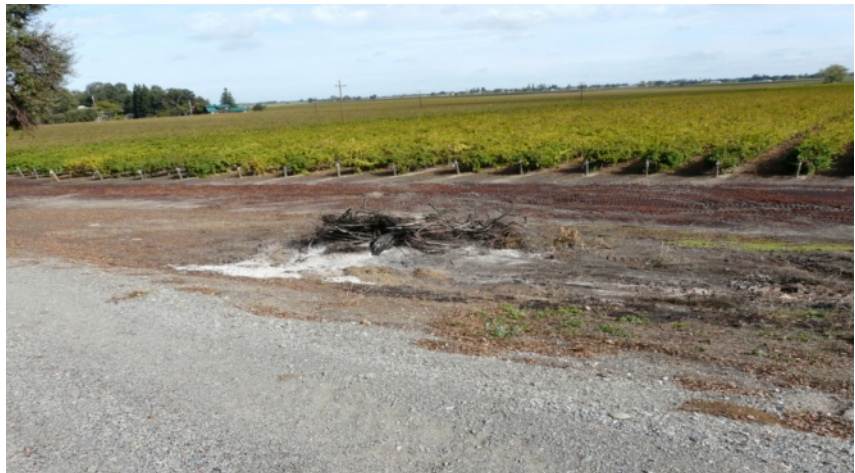
Levee Mile Report Line	31
Start Levee Mile	6.65
End Levee Mile	6.65
Location	
Category	Earthen Levee
Item	Encroachments
Remove debris from landward slope at LM 6.65.

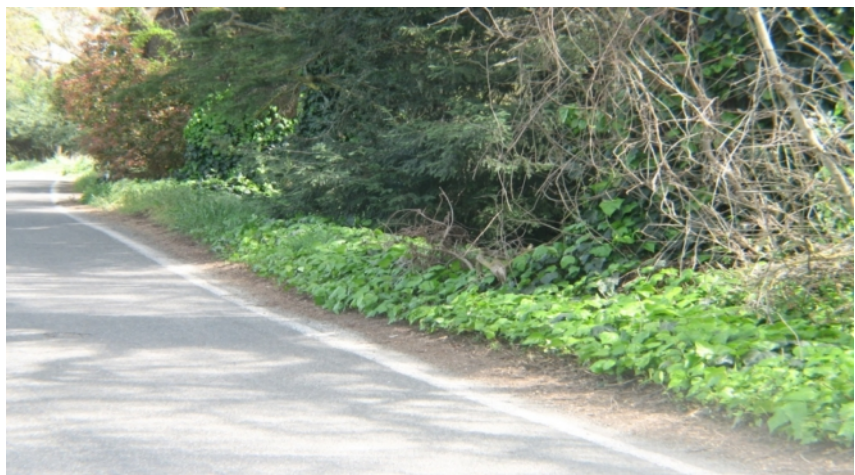
Levee Mile Report Line	34
Start Levee Mile	6.87
End Levee Mile	6.95
Location	
Category	Earthen Levee
Item	Encroachments
Landscaping on landward slope blocking view from LM 6.87 to 6.95
